DIAGNOSTIC SIGNIFICANCE OF MACRO- AND MICROSCOPIC
FEATURES OF CATASTROPHIC GUN-TUBE FAILURES.

MR. ROBERT L. HUDDLESTON
MATERIEL TESTING DIRECTORATE
ABERDEEN PROVING GROUND, MD. 21005

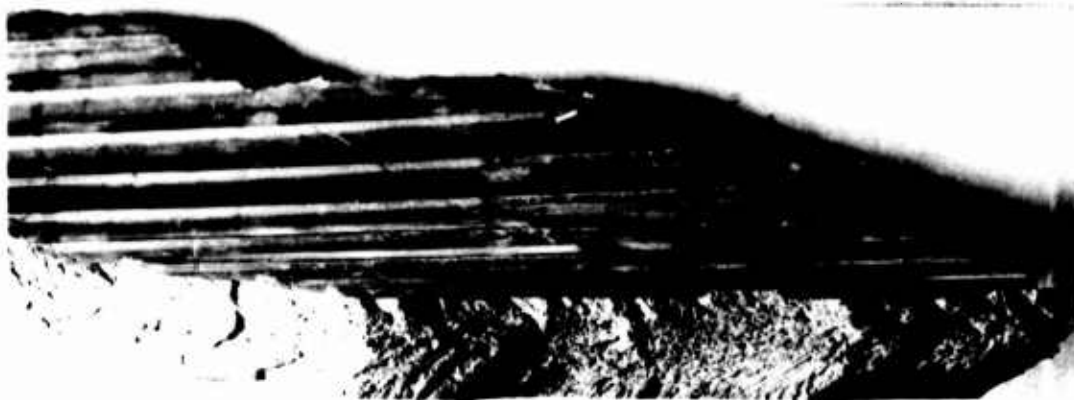
It is important to examine metal fracture surfaces before rapid corrosion sets in to conceal vital indications on the fresh, highly energetic surface. Fracture tracing can be done on mixed-mode fracture surfaces that reveal a "herringbone" or "chevron" pattern, indicating the direction of crack propagation. The chevron "V's" point toward the direction of propagation when the fragments are re-assembled, in jigsaw fashion.

FIG. 1 Chevron Fracture (1X)

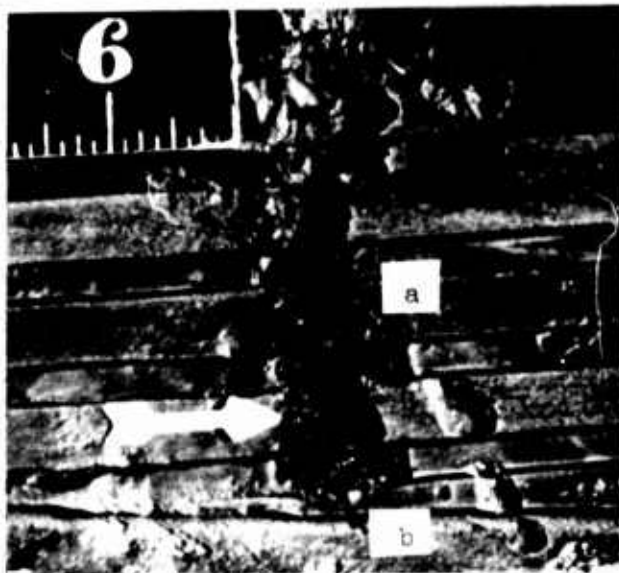
HE shell of several types have been shown to produce a circumferential ring of pits or fragment indentations corresponding to the ogive area of the shell. These pits increase the depth as the nose of the shell is approached. Apparently, the shell body, which is in close contact with the bore, does not fragment as does the

FIG. 3 Fragment Ring

unsupported ogive, fragments of which are projected into the tube at an angle, as driven by the expanding gases. HE antitank rounds (HEAT) produce an especially distinct nose fragment ring when they function in-bore.

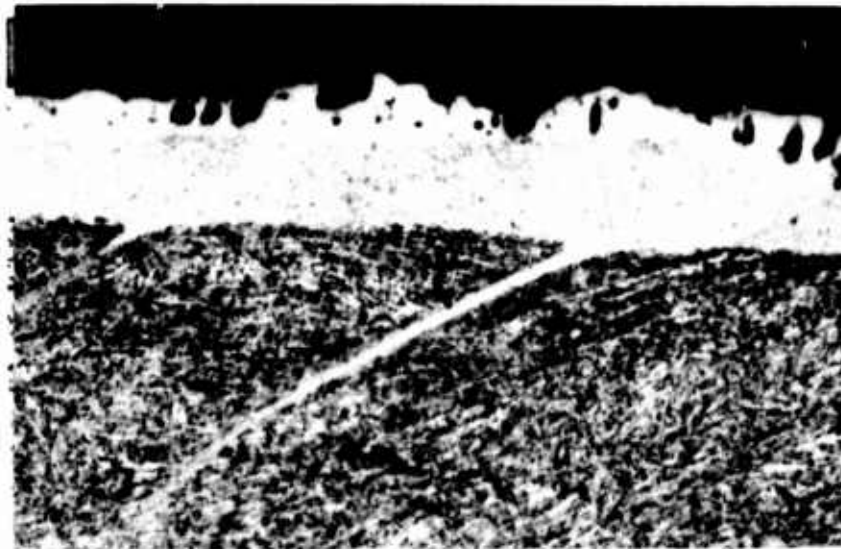
One of the more striking features produced by any order of detonation with sufficient force to rupture a tube is the martensitic streaks, which have been described as being caused by adiabatic shear (2). These indicate the presence of intense shear loading but,

FIG. 4 Adiabatic Shear (500X)

unfortunately, cannot be used to distinguish between high- and low-order detonations since they occur for both conditions. It has been thought that the direction of these "streaks" could be related to the direction of principal stress propagation, but to date they have not proved to be useful for this purpose. During the breakup of a gun tube in the presence of an explosion, the shocks and reflections appear to form a virtual "tangle" and the direction of any given shear line and the direction of main stress propagation appear to be unrelated. Further observations are needed to better determine the usefulness of this observed phenomenon.

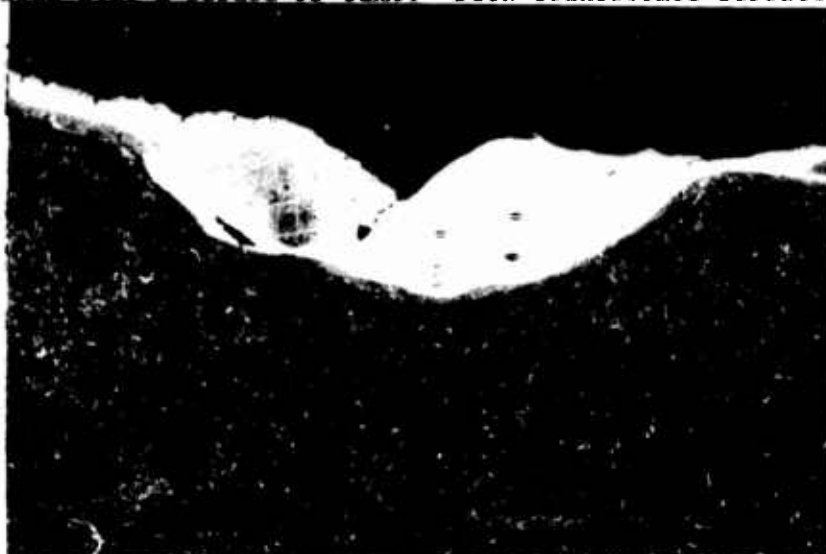
Another unusual condition has been noted on the surface of both tube and projectile fragments from in-bore prematures. A duplex white layer has been observed; this resembles the white layer seen by many examiners of worn gun tubes, believed to result from heat and the nitrogen from the propellant gases. One reference (3) reports the observation of three distinct zones: a) a subsurface tempered zone, softer than the underlying steel; b) a rehardened light etching, nearer the surface area; and c) a darker etching platelet containing layer at the surface. We have observed similar layers on tube and shell fragments and, at least in the case of the shell, the transformations resulted from the single explosion, not a large number of rounds fired over a period of time. Such transformed surface layers

FIG. 5 Layers on Shell (100X)

have not been observed on recovered shell that were fired under normal conditions and apparently are caused by the intense heat, possibly in combination with the pressure of the detonation gases. Almost all fracture surfaces of tube and shell fragments exhibit a gas-washed surface layer. This alteration of fracture surfaces, by masking

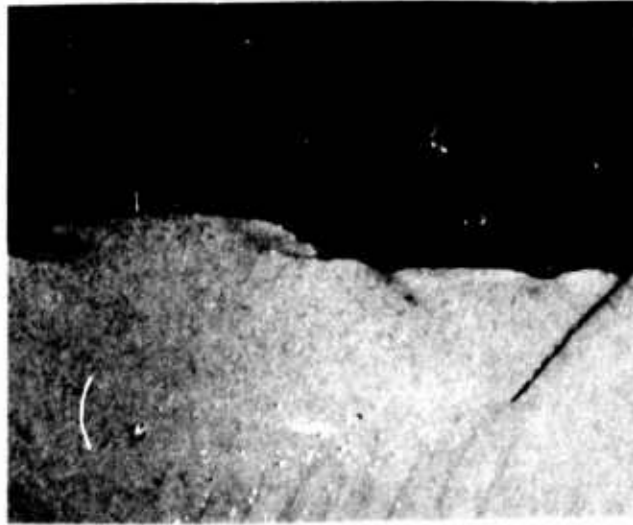
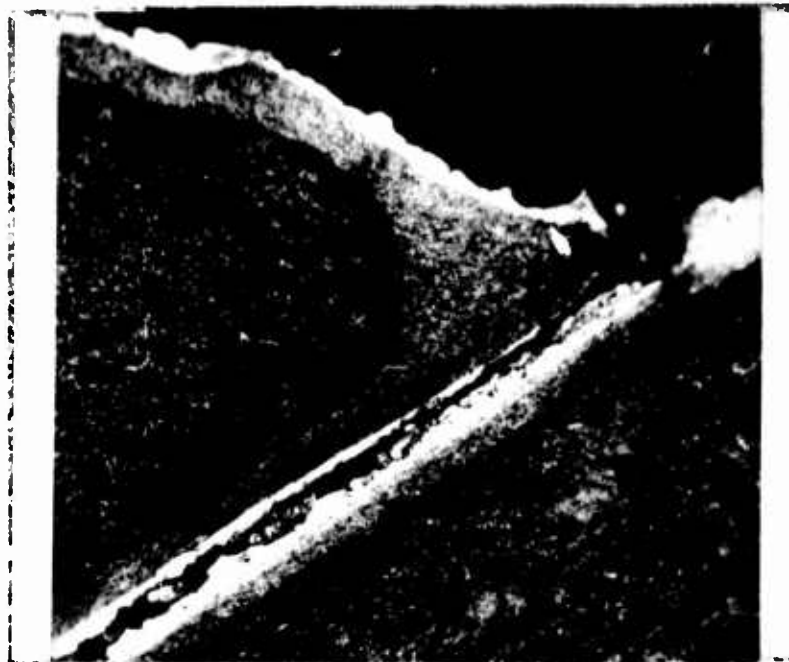
fracture detail, has seriously impeded efforts to better analyze fracture surfaces with the scanning electron microscope. The diagnostic significance of this observation is that the presence of a "white layer" in surface cracks in tube fragments after detonation is not necessarily evidence of a pre-existing fatigue crack, as has been believed by some investigators.

FIG. 6 White Layer in Shear Crack (Top 8X, Bottom 250X)
